The removal of ink trails or 'dribble' lines from prints.

Hints & Tips

Advice from FUJIFILM Sericol Technical Services

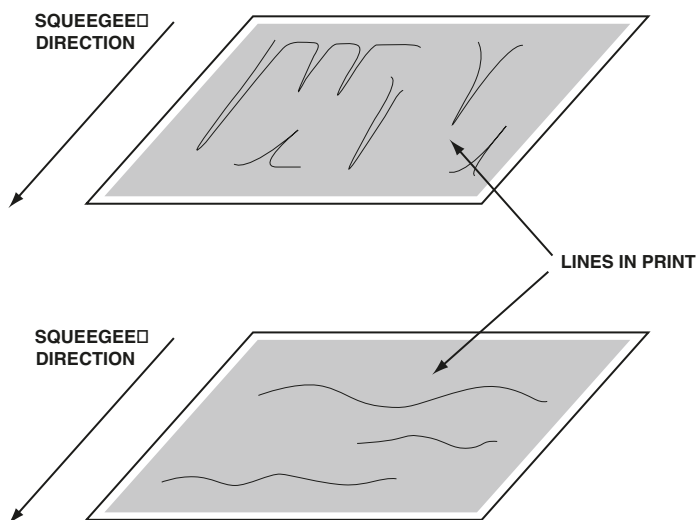
Diagram

1. Dark lines running through the print in the direction of the flood/print stroke.
2. Dark wavy lines running across the print horizontal to the flood/print stroke.

These lines correspond to areas where ink has dropped from the flood coater or the squeegee during the print or flood strokes leaving a thicker layer of ink on certain parts of the screen. The thicker layer then prints as a dark line or streak.

With the combination of thin high definition ink and mesh the ink flows less freely through the screen resulting in a slightly lighter print than might be expected. In the areas where the ink has dribbled onto the screen from the squeegee or flood coater a thicker layer prints a little darker showing itself as a dribble line or trail.

This problem is primarily one of ink starvation or general poor flow through the mesh. This results in the ink printing lighter on the bulk of the print and closer to its correct colour density in areas where ink has fallen from the flood coater or squeegee onto the mesh.

1. Thin the ink more - this will not stop the ink dropping from the coater/squeegee but will facilitate greater ink flow through the mesh, thus hiding these trails.

2. Slow the machine down - slowing the print and flood strokes often eliminates the problem.
3. Change the squeegee conditions by:
 - (a) Using a little more pressure.

- (b) Using a lower, less upright angle
 - (c) Using a softer rubber.All of the above will increase ink flow through the mesh.
4. Reduce the gap between the squeegee and the flood coater and make sure that the gap is full of ink at all times.

5. Varying the flood thickness (both thicker and thinner) may sometimes help to eliminate ink trails depending on the type of ink being used.
6. Probably the best solution is to use a higher deposit mesh, preferably one with a greater percentage open area, to allow the ink to pass more easily through the mesh onto the substrate.
eg. moving from a 150.34PW to a 150.31PW or a 140.34PW may help.
